Churchrock Area Uranium Monitoring Review

*Orientation for Chapter Officials
Churchrock Chapter House
Feb. 5, 2009*

**Church Rock Uranium Monitoring Project (CRUMP)
Diné for Environmental Health (DiNEH) Project
Multicultural Alliance for a Safe Environment (MASE)
Red Water Pond Road Community Association
Southwest Research and Information Center (SRIC)**

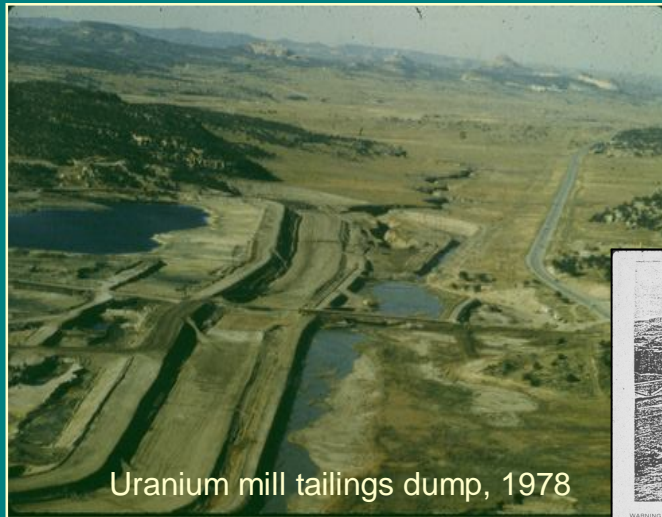
Uranium mill tailings dump, 1978

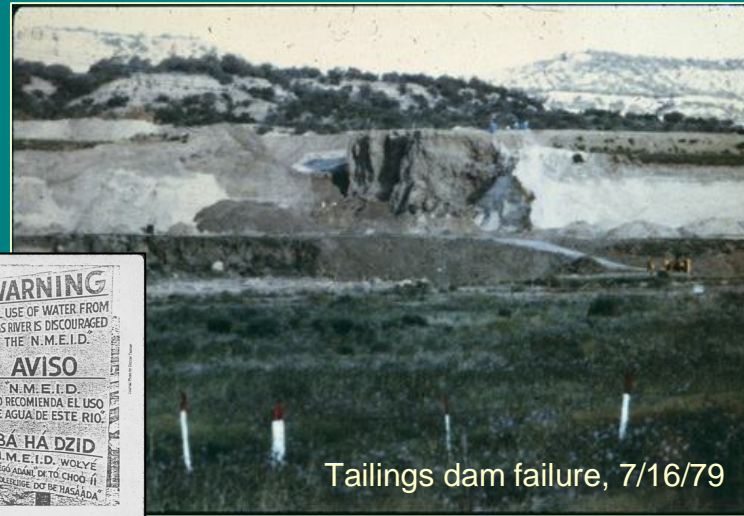
Tailings dam failure, 7/16/79

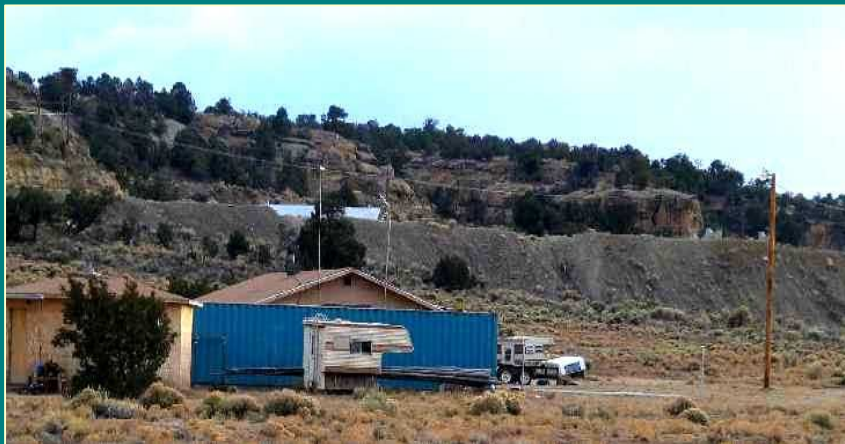
Navajo home next to uranium mine waste dump, 2005

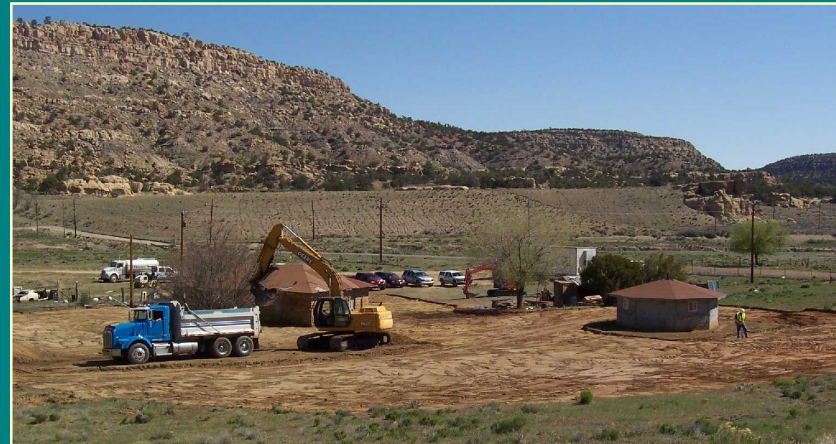
Radium-contaminated soil removal, Red Water Pond Road, 2007; partially reclaimed abandoned mine in rear

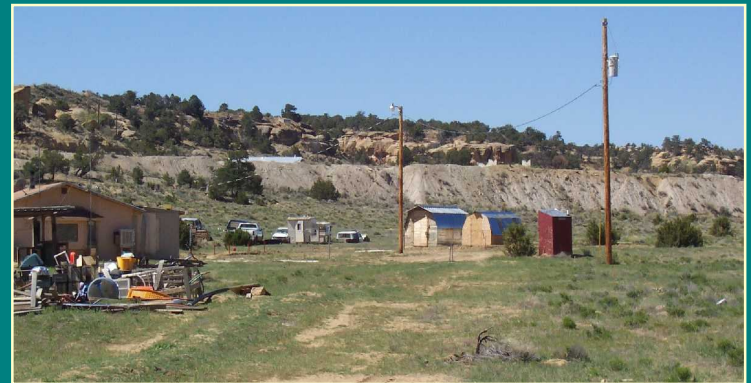
Unreclaimed mine waste dump
next to residence, 2007

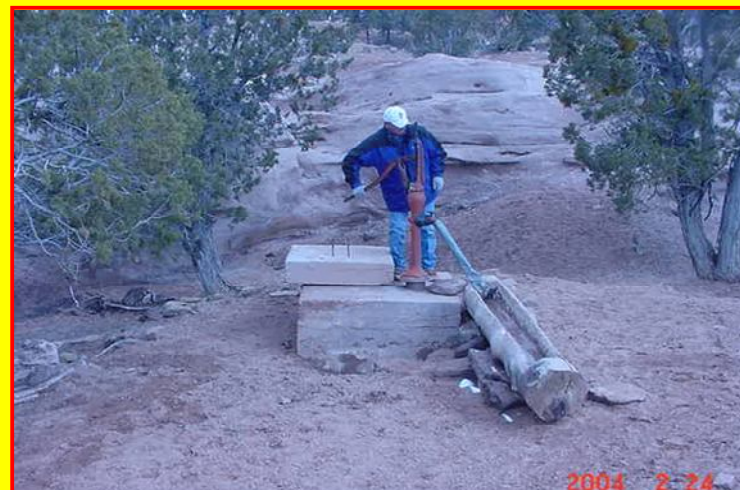
**Water from Lime Ridge Handpump*
(16-4-10) in Churchrock Chapter
is NOT safe to drink**

****Uranium, gross alpha radioactivity and
radium exceed drinking water standards***

Advisory issued May 2008 by

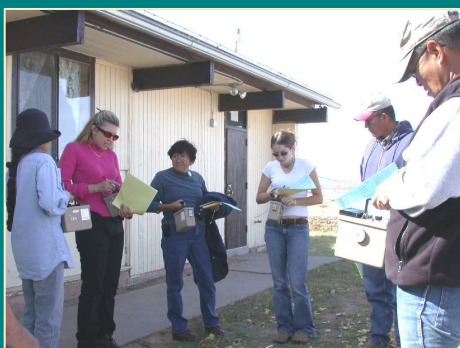
- 20+ people from Churchrock, Navajo Nation, SRIC, TAMS Center, USEPA participated in surface gamma surveys
 - community members trained in instrument calibration, field use, data transcription (left)

- Gamma radiation levels measured with hand-held instruments (middle and bottom left), USEPA “Scanner Van” (below) in October 2003

- Hand-held: Ludlum-19 gamma detectors, lent by NNEPA-Superfund, Navajo AML
- Scanner Van: 2 Sodium-Iodide (Nai) detectors that “scan” up to 200’ from truck; provided by USEPA Las Vegas lab

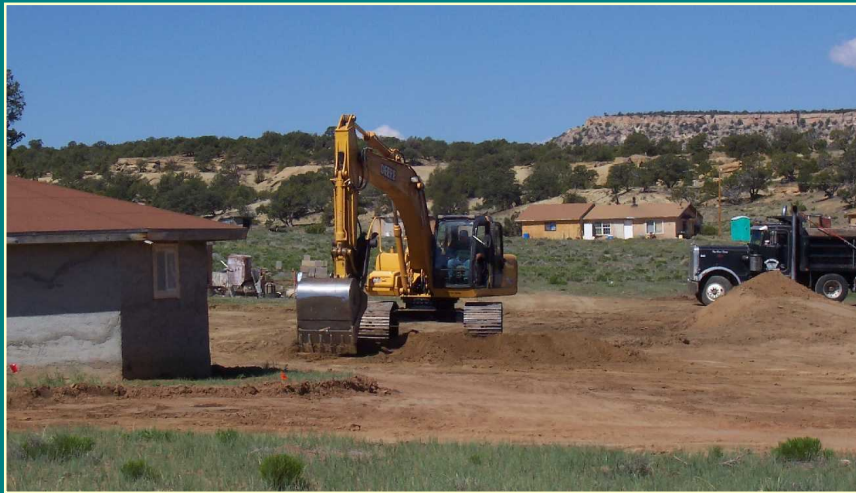
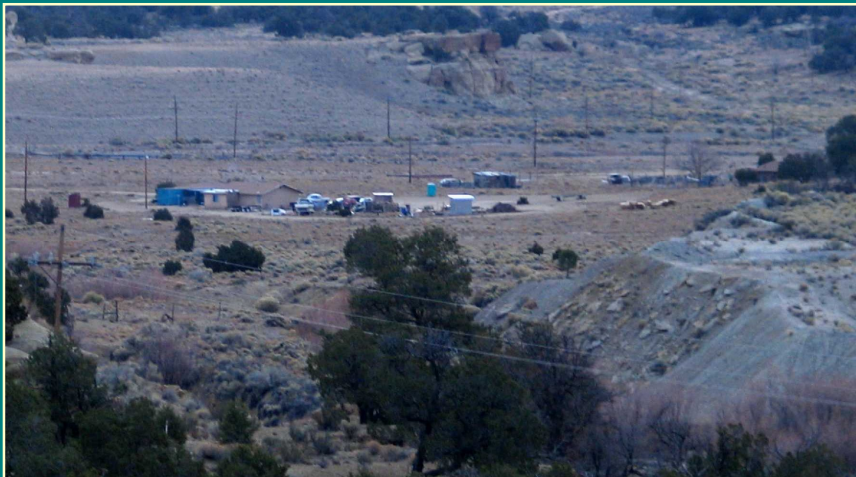
- CRUMP gamma surveys, uranium-in-soil studies prompted responses by USEPA, NNEPA
- May 2007: USEPA removed nearly 6,000 cubic yards of radium-contaminated soils from around residences (upper left)
 - Soil removal may not be sufficient for long-term protection of public health
- 2007-2009: Reclamation of NECR mine site (lower left)
 - Goal of community, Navajo Nation is complete removal of mine wastes from tribal trust land

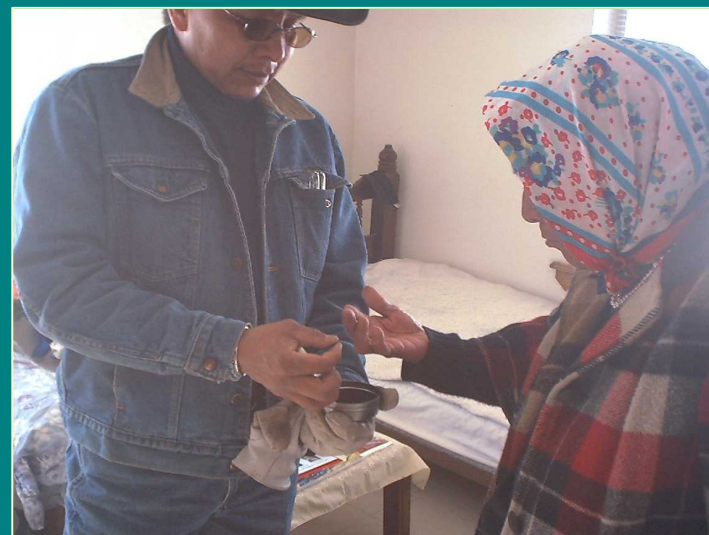
John Plummer, NNEPA Radon Program, shows Pipeline Road resident the charcoal inside a radon canister

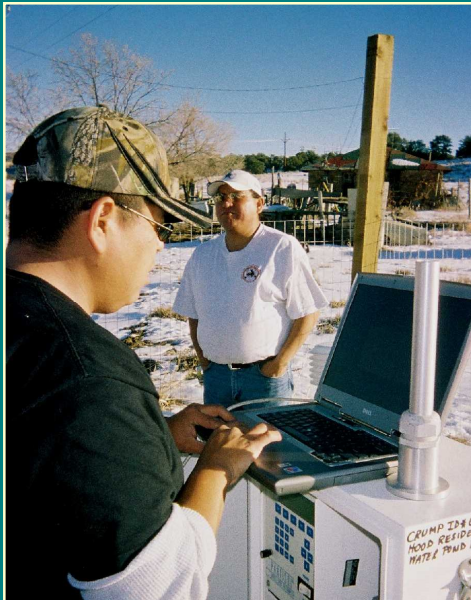
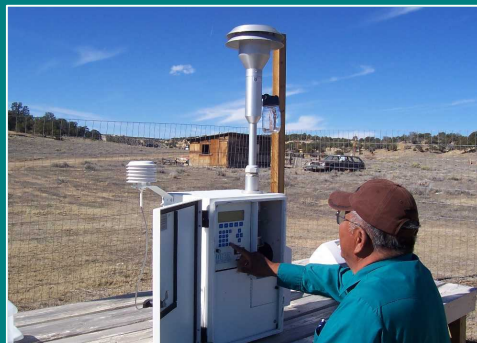
- Monitoring began May 2006
- Two sites: Red Water Pond Road, Pipeline Canyon Road close to residences, abandoned mines
- Compare dust levels with federal particulate limits
 - Through December 2008, highest 24-hr concentration was 15% of national air quality standard for particulate matter
- Requesting USEPA-LV lab analyze 10% of filters for radionuclides
- Develop, validate predictive model of inhalation exposure
